ALMANDA SILVER MINE

A guide to the walking trail

DEPARTMENT OF
MINES AND ENERGY

Interpretive Trail

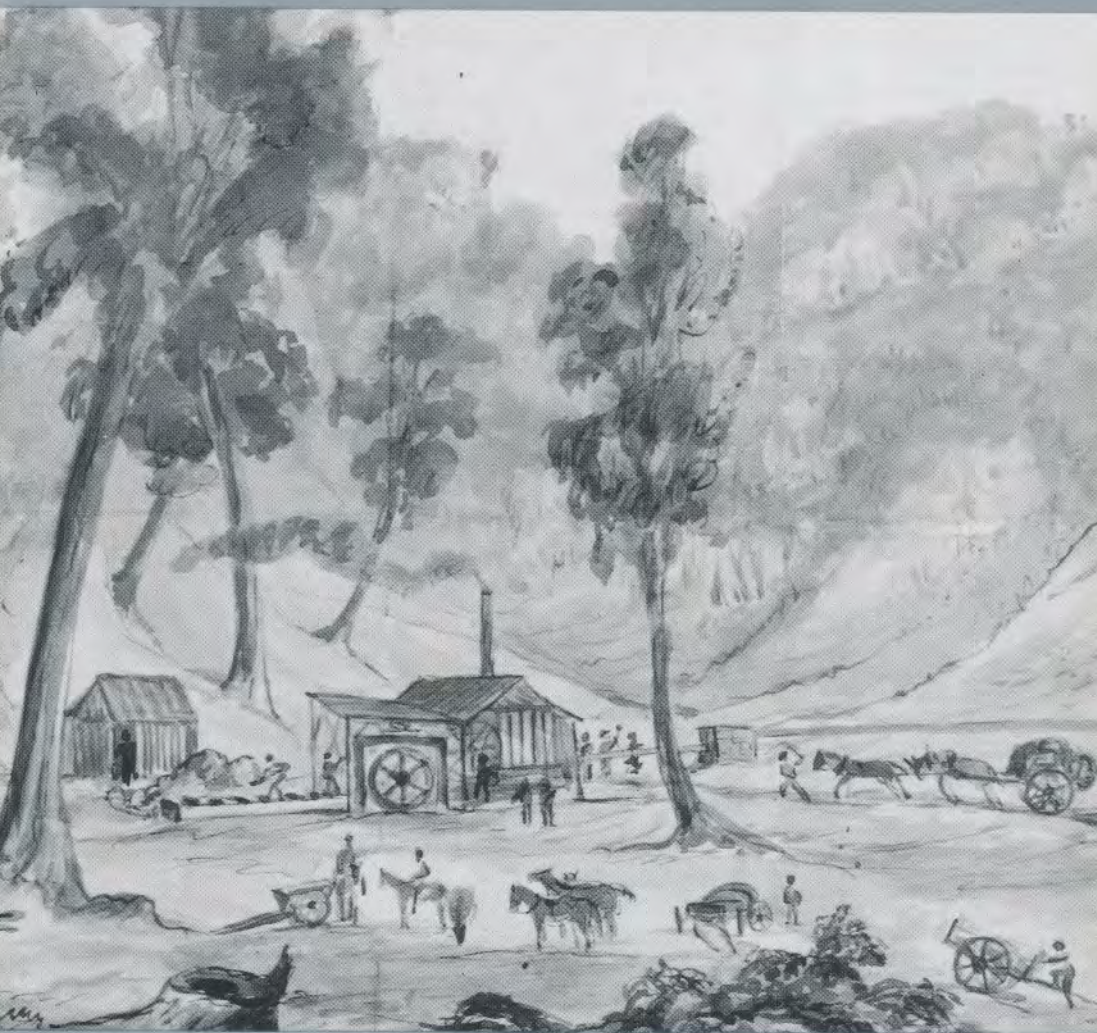
COVER: *The Almanda Mine, 1868, by W.A. Cawthorne, showing the first treatment plant erected in 1868. The shed (centre) contained a stamp battery and Chilian mill. A water race entered the shed at the right. This plant was situated near the present car park. Mitchell Library, State Library of NSW.*

By August 1868, twenty miners were employed under Captain Henkel, and Ey supervised the erection of a treatment plant, which comprised a 10-head stamp battery, Chilian mill and concentration tables (see cover). This plant proved very ineffective and was replaced by a more powerful engine, 15-head battery and improved concentrating machinery in 1869. About 1500 tons of ore, mainly from Eys Workings, had been stockpiled when the new plant commenced in July 1869.

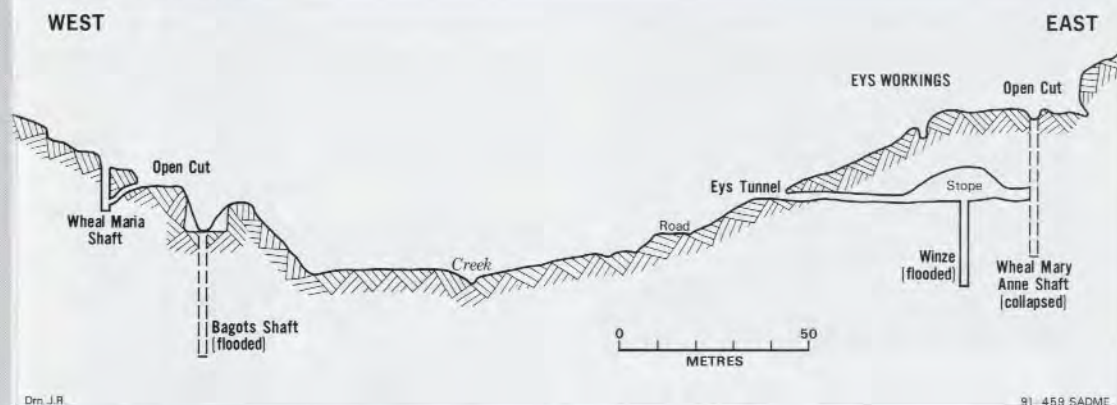
Longitudinal section of the Almanda Mine.

The mineralised lode or ore zone occurs along a steeply dipping, east-west trending fault zone within deeply weathered shale of Precambrian age. The lode outcrops as a narrow iron-rich band up to 1.5 metres wide over a length of 800 metres. This was mined from two sets of underground workings located on both sides of a narrow valley. Those on the eastern side of the valley are known as Eys Workings and include a tunnel and open cut, where the lode was mined over a length of 20 metres. On the western side is the site of the Wheal Maria Shaft and a small open cut along the exposed lode.

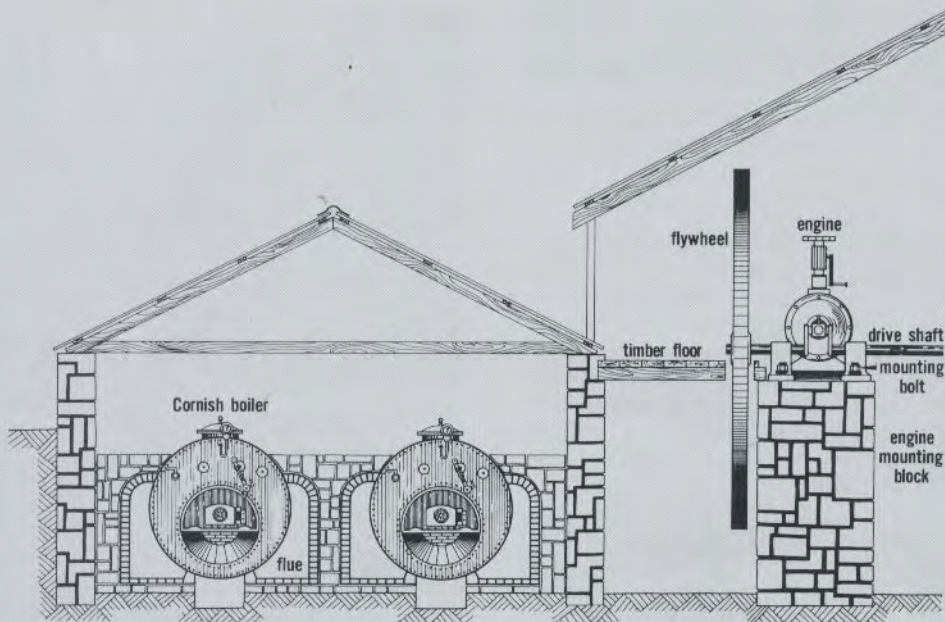
91-460 SADME

An impression of the interior of the boilerhouse and enginehouse erected in 1869 (Locality 8). The engine powered a 15-head stamp battery and concentrating machinery which were located in an iron shed to the right of the engine.

8. Enginehouse Ruins: the stonework is the remains of the ore treatment plant erected in 1869. The location of two Cornish boilers and the mounting block for a steam engine are visible. Inspect the underground flue running up to the chimney. Note the large hand-cut blocks of sandstone used for the engine mounting block.

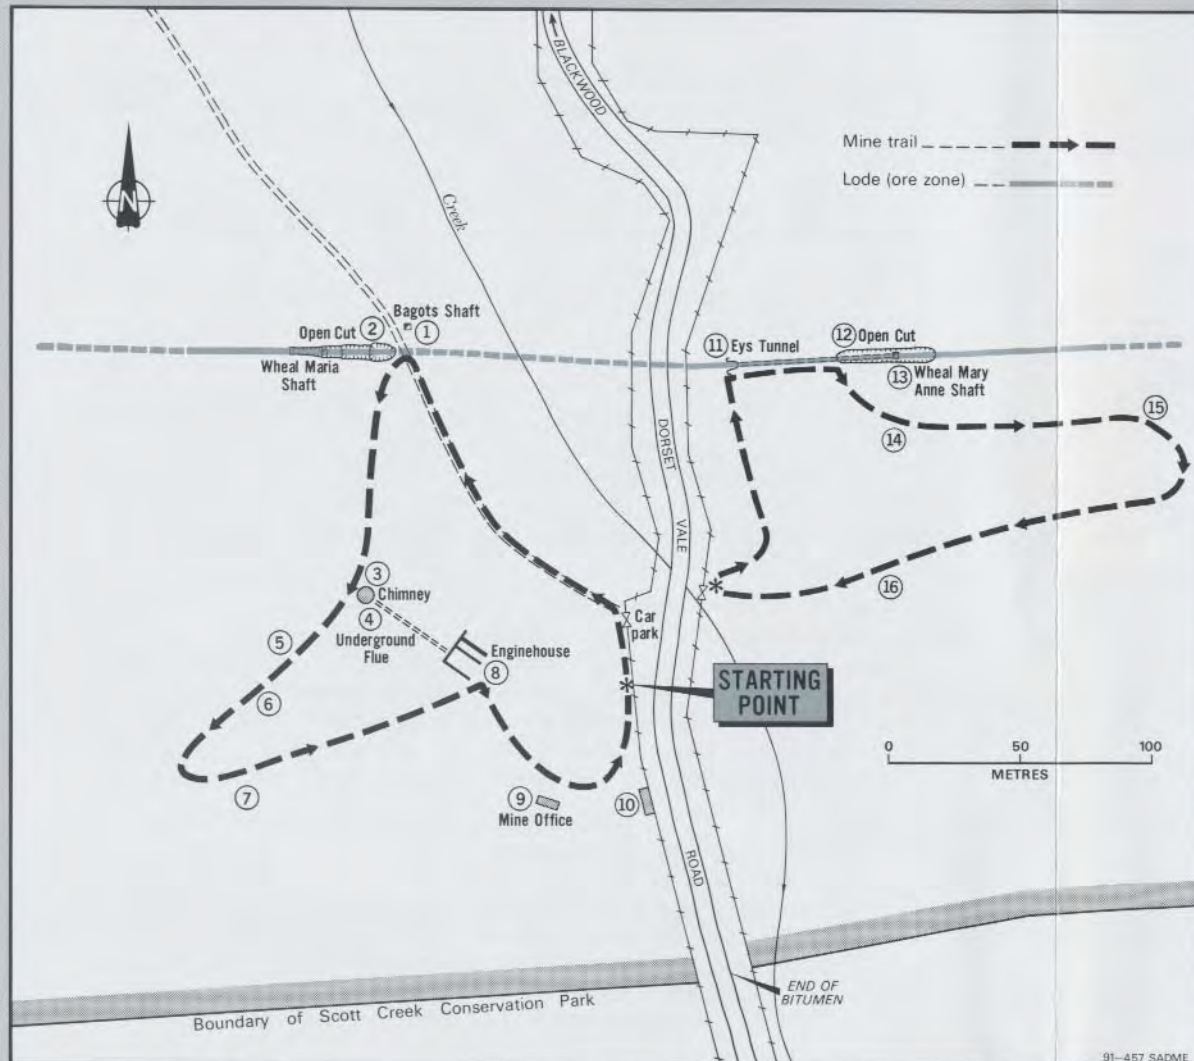
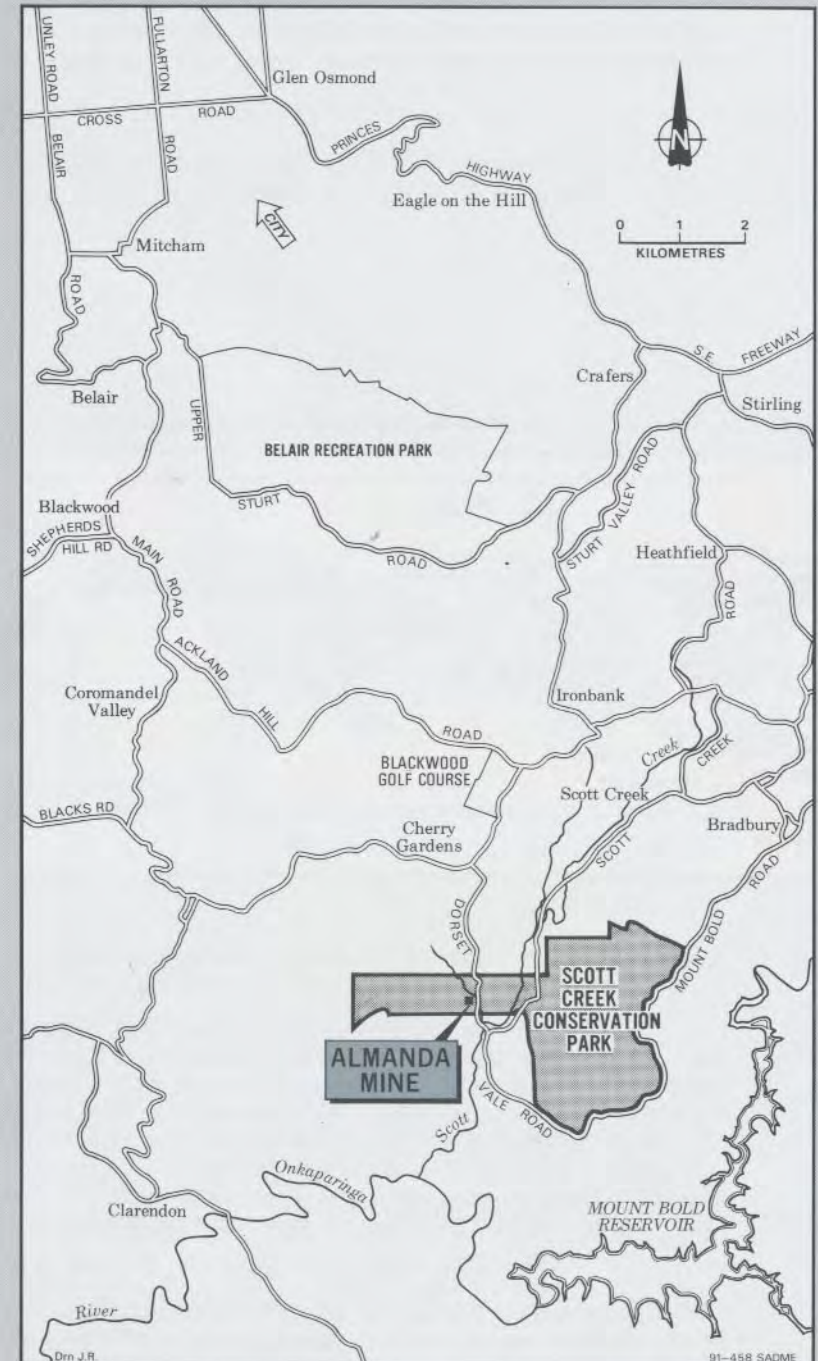
THE TRAIL

Explore the mine area on two short loops which each take 1/2 to 1 hour to complete. Interpretive signs illustrate the nature of the orebody and methods of mining and treatment. The trail includes a tunnel, which must only be inspected with TORCHES.

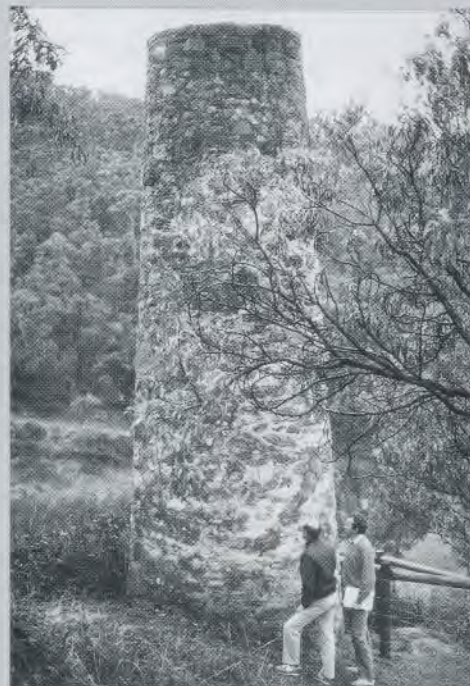
Almanda Mine chimney.

3. Chimney: this stone chimney was erected in 1869 and connected by an underground, stone-lined flue, producing underground, to a boilerhouse lower down the hill.

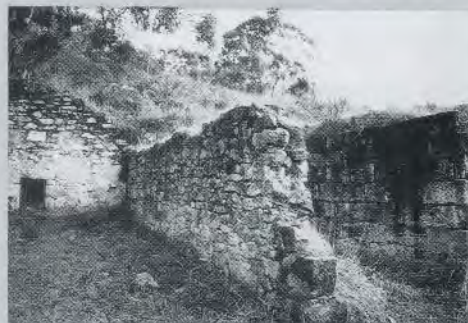
Enginehouse ruins with engine mounting block (right) and boilerhouse (left). Note the square opening to the underground flue at left.

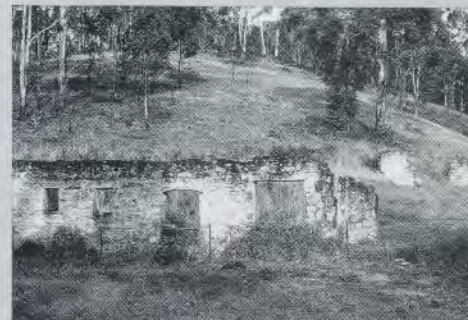
9. Mine Office: this stonework marks the probable site of the mine office and captain's residence erected in 1868. Edward Henkel was appointed Captain in 1868 and was replaced by Bennett Opie in 1869.

10. Dairy: this was erected in the early 1900s by the Mitchell family using some large dimension stones from the nearby enginehouse. An old tractor survives from the era of the dairy.

Ruins of dairy with mine office in the background.

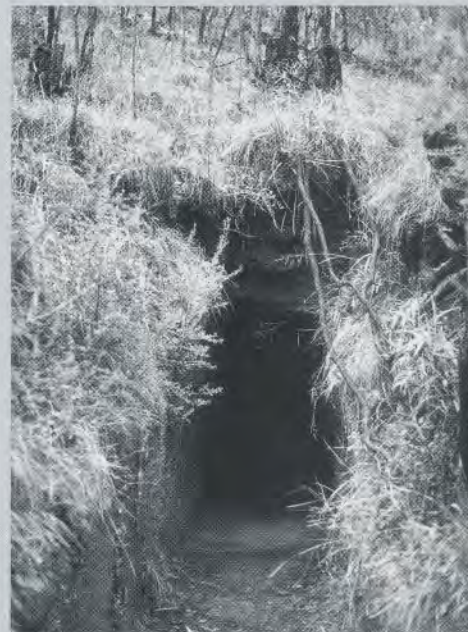
Entrance to Eys Tunnel.

11. Eys Tunnel: this 60 metre long tunnel was driven along the lode in 1868 to connect with the Wheal Mary Anne Shaft above. The lode outcrops between the tunnel entrance and the open cut above. Ore was extracted from the tunnel leaving an opening or *stope*. The lode is visible in the roof of the stope. An internal shaft or *winze* was sunk to 23 metres in 1881. **Torches must be used.**

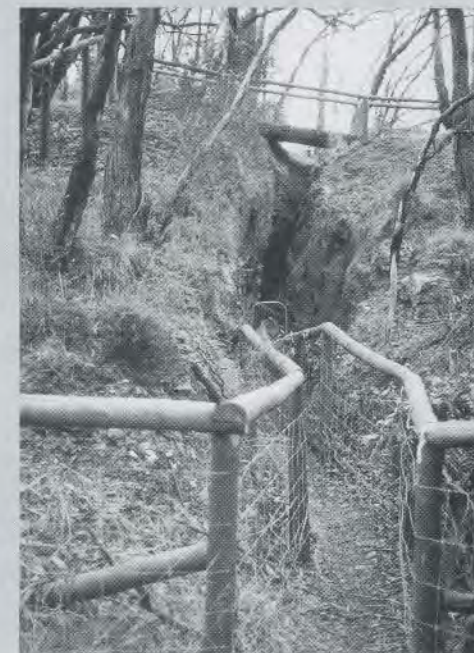
Open cut showing the narrow nature of the lode.

12. Open Cut: this was formed by excavation of an old tunnel to the surface in 1887.

13. Wheal Mary Anne Shaft: this shaft was sunk on the lode to 27 metres in 1862. The collapsed shaft can be seen in the middle of the open cut below the bridge.
